LANDSLIDES AND RELATED FEATURES

OF THE HACKER VALLEY, W. VA. QUADRANGLE

OPEN FILE MAP 85-80 (P-13)

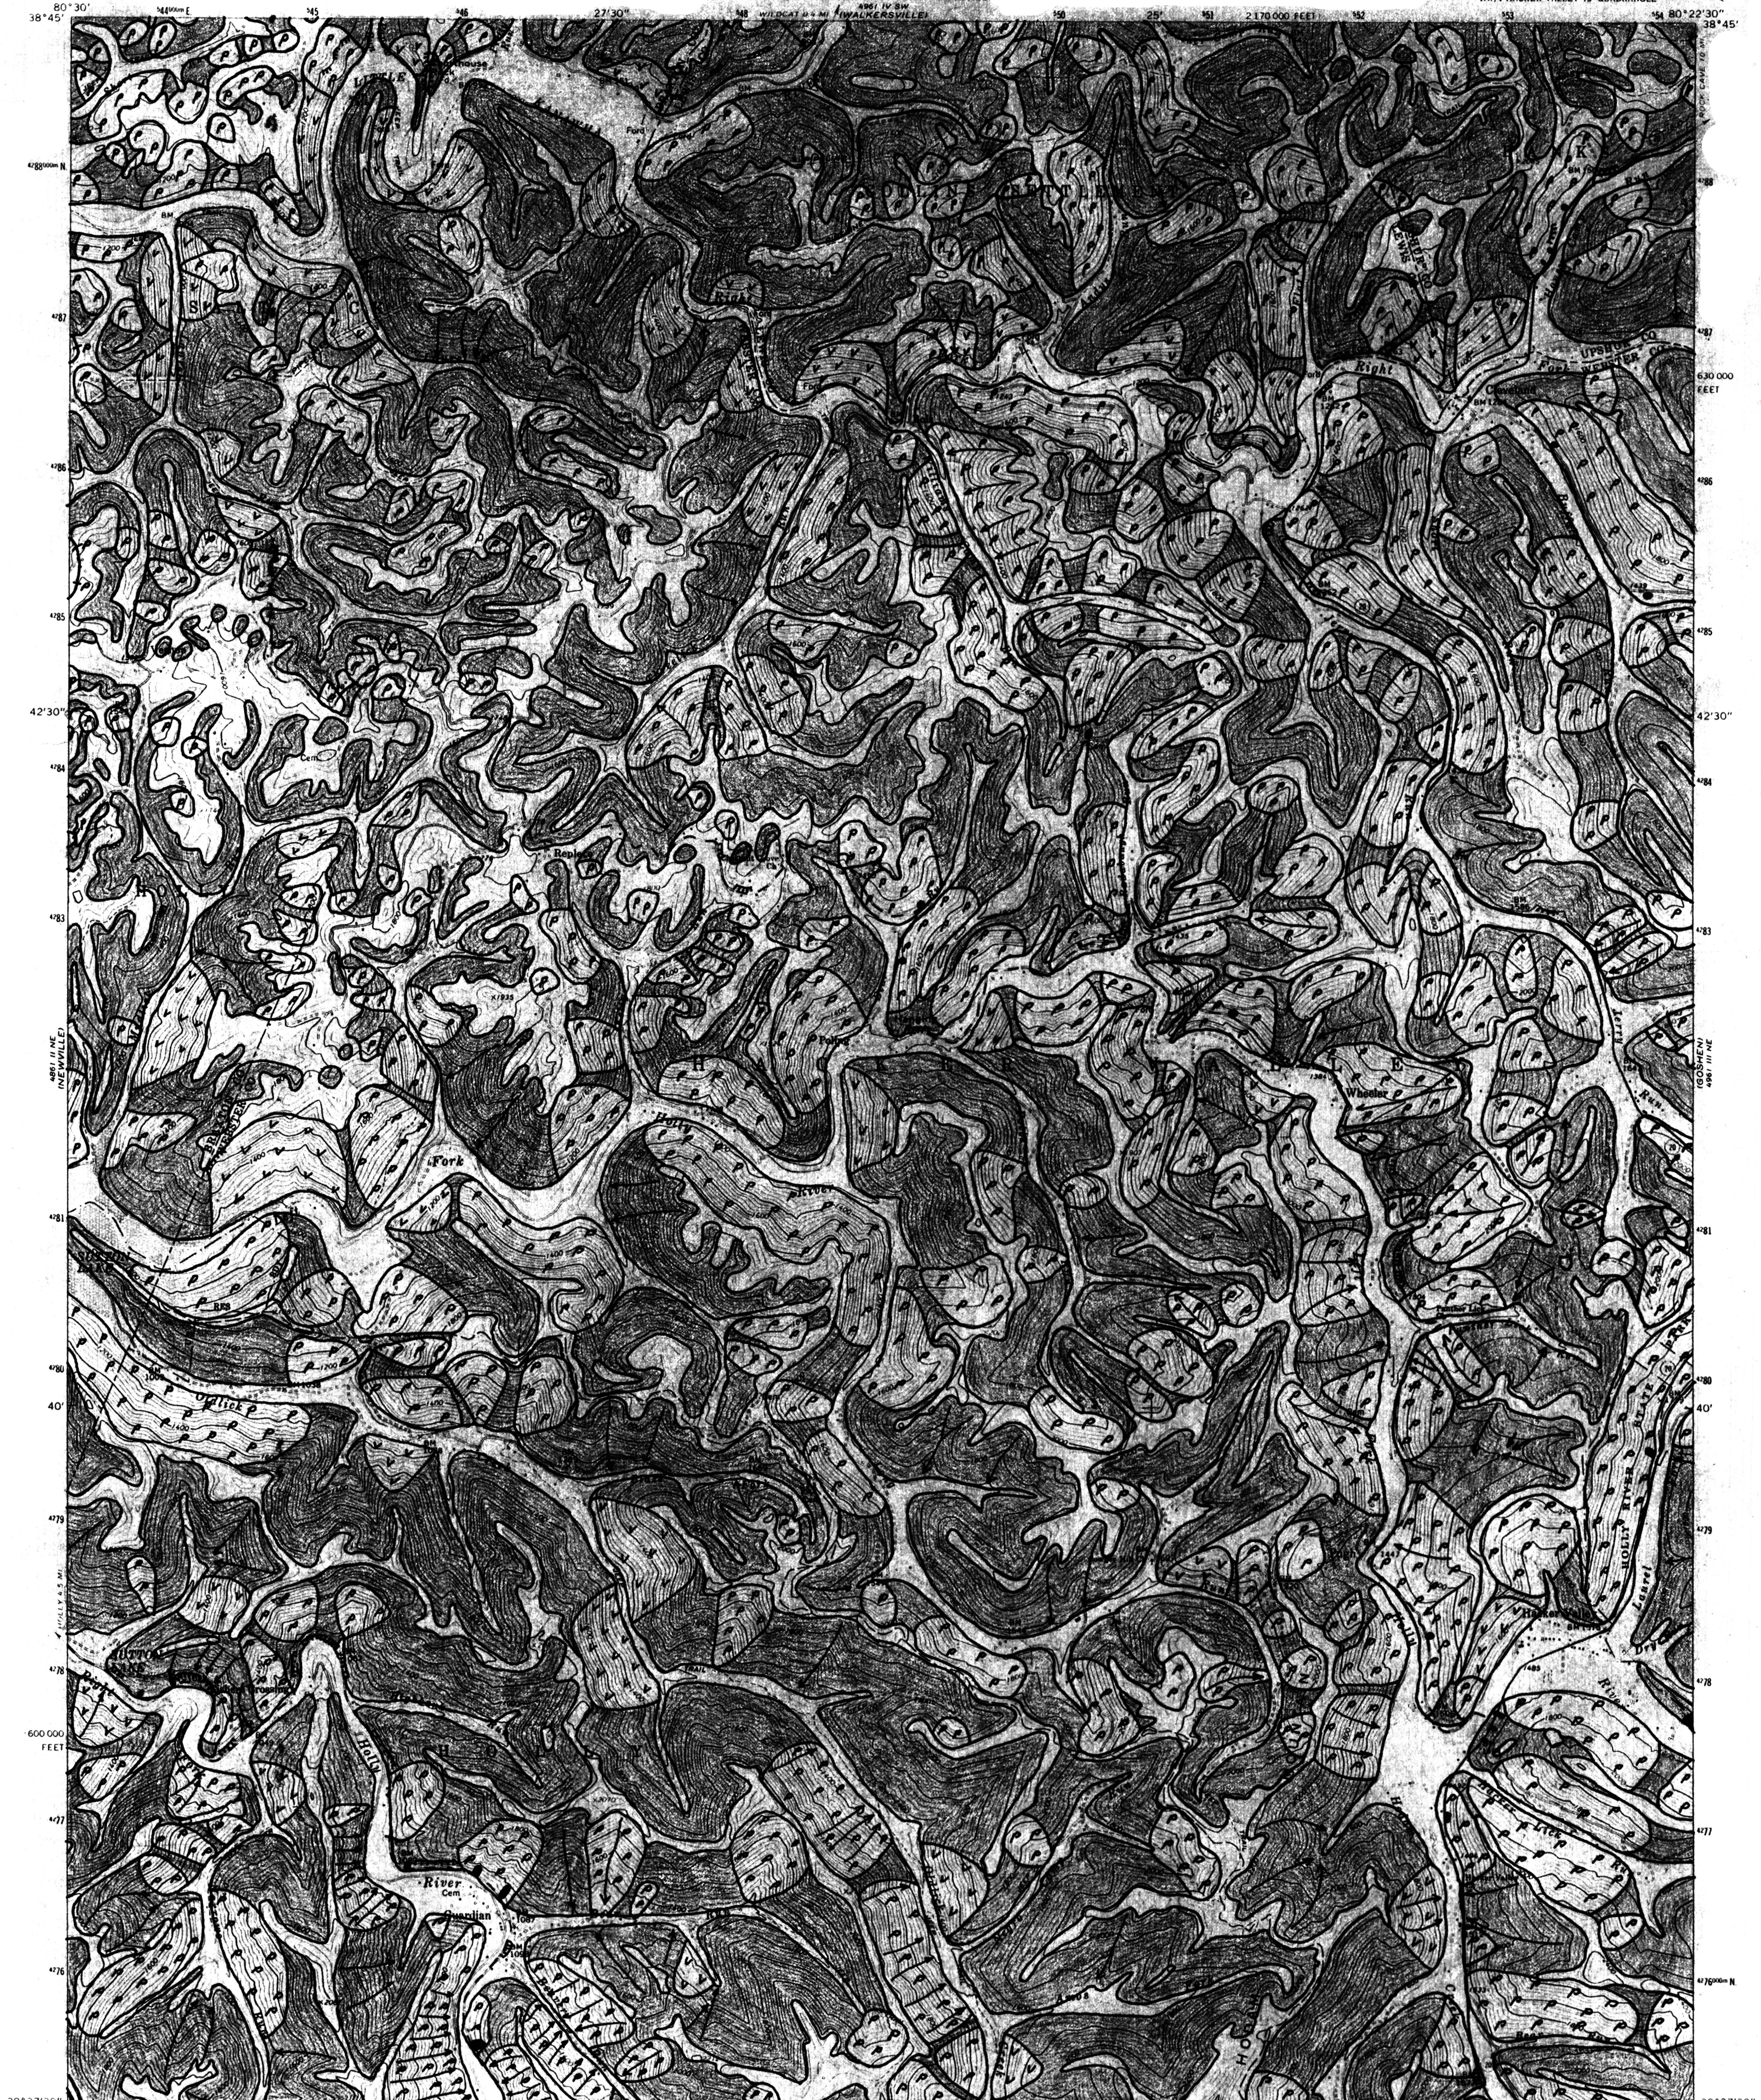
HACKER VALLEY, W. VA.
NW 1/4 HACKER VALLEY 15 QUADRANGLE
N3837.5—W8022.5/7.5

Landslides and related features interpreted
from aerial photographs:
1:60,000 SCALE BLACK AND WHITE 1960
1:125,000 SCALE COLOR INFRARED 1973
1:80,000 SCALE BLACK AND WHITE 1976

Photointerpretation and field check 1981.
This map has not been edited or reviewed
for conformity with Geological Survey
standards and nomenclature.

ACTIVE OR RECENTLY ACTIVE LANDSLIDE
Complex landslide composed of earthflow, debris
slide, earth and rock slump. Identified from
historical records, and from scars, debris and
other field evidence. Ground extremely unstable,
sliding accelerated by excavation, loading and
changes in drainage conditions. May include
areas with several active slides too small to
be shown separately.

OLD LANDSLIDE
Area of extensive hummocky ground caused by
earthflow and earth and rock slump. Lacks
clear evidence of active sliding. Relatively
stable in natural, undisturbed state,
generally not affected by small structures properly
sited in areas away from the edge of the toe,
can be reactivated by extensive, rapid exca-
vation, loading, and changes in ground water and
surface water conditions. Area of old landslide
probably includes recent ones not identified
from field evidence or otherwise documented.
Upslope boundary of landslide generally defined
by modified scarp, but downslope (toe) may be
gradational and not well defined.

COLLUVIAL SLOPE
Valley wall along major streams with slope as
steep as 40° (85%), stony, clayey silt soil up
to 50 ft. (15 m) thick; commonly buttressed by
a terrace or bench at the toe of the slope; very
susceptible to sliding by cutting of toe area,
removal of terrace or bench, and overloading;
slide commonly activated without apparent cause.

AREAS SUSCEPTIBLE TO DEBRIS FLOWS AND DEBRIS
AVALANCHES
Primarily shallow, narrow ravines and chutes with
accumulation of stony colluvium generally 10 ft.
(3 m) or less in thickness; susceptible to rapid
movement during intense rainfall. Most ravines
and chutes designated show evidence of former
debris flows and avalanches. Symbol 'a' design-
ates historical debris flow or debris avalanche.

AREAS SUSCEPTIBLE TO ROCKFALL
Steep, locally vertical, natural and man-made
slopes and cliffs, 15 ft. (4.5 m) or more high,
formed dominantly of sandstone, limestone, sandy
shale, mudstone and claystone. Interbedded mud-
stone, claystone and shale weather rapidly leaving
sandstone and limestone rock faces unsupported.

SOIL AND ROCK SUSCEPTIBLE TO LANDSLIDING
Soil and rock similar to that involved in land-
slides elsewhere in map area; primarily areas
underlain by claystone, mudstone and shale
associated with other rock types. Rock weathers
rapidly on exposure forming clayey soil highly
susceptible to sliding. Includes covers (U-shaped,
shallow valleys) containing thick layers of clayey
soil that are very susceptible to sliding where
excavation breaks continuity of slope and where
overloaded by artificial fill.

AREAS LEAST PRONE TO LANDSLIDES
Map areas in which no patterns or symbols are shown;
primarily valley floors, ridge tops and broad
benches; modification by excavation and fill may
lead to local landslides.
